Manhole Inspection Summary

Manhole # S31AA_038MH

Insp Date: **2/28/07 8:12 AM**

Location Address: **EUTAW ST**

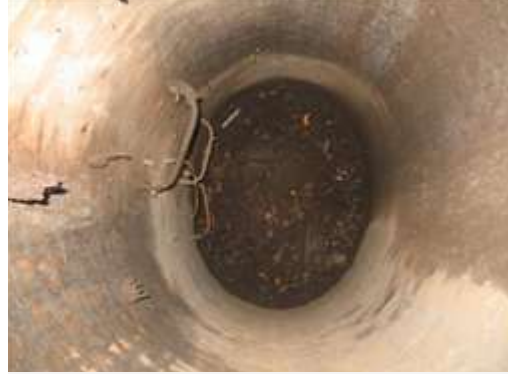
Top View

Corroded and missing steps. Channel debris.

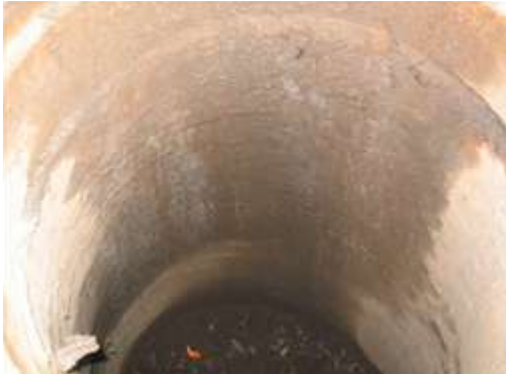
Defect

Frame leaks. Adjustment and Barrel infiltration.

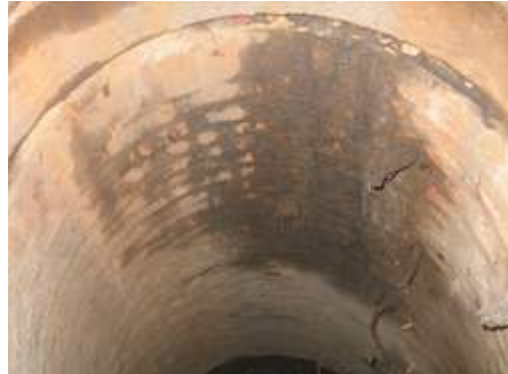
Defect

Frame leaks. Adjustment and Corbel infiltration.

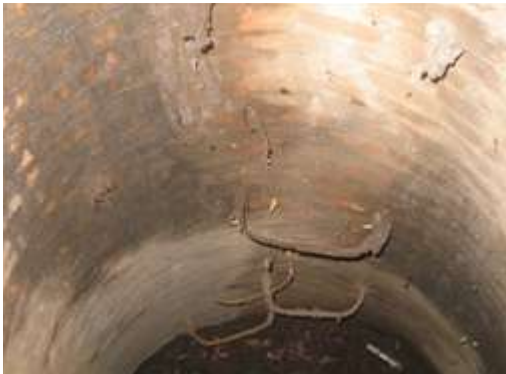
Defect

Corroded and missing steps.
